REPORT OF INVESTIGATION

Underground Metal Mine  
(Platinum)

Fatal Machinery Accident  
April 28, 2005

Stillwater Mine  
Stillwater Mining Company  
Nye, Stillwater County, Montana  
Mine I.D. No. 24-01490

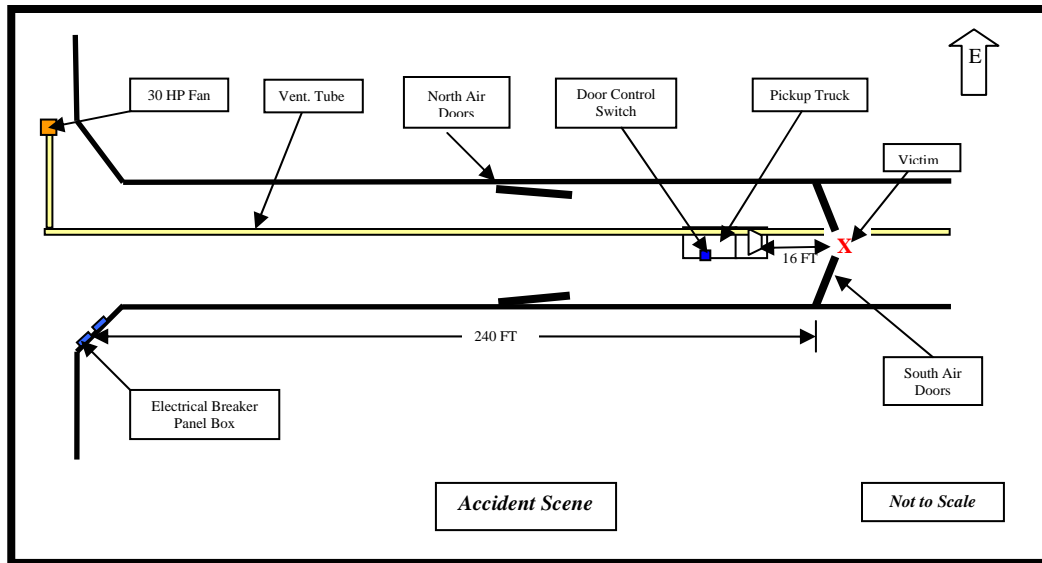
**Figure No. 1**

The air lock system at the accident site consisted of two sets of air-actuated metal doors operated by electrical controls. The general direction of the doors within the drift was identified as the north set and the south set. The victim was found pinned in the south set of doors. A sketch of the accident scene is shown in Figure No. 1. Both sets of doors operated independently of each other and had two pull-type control switches suspended in the drift for each set of doors, one on each side of the respective set of doors, to open and/or close that specific set of doors. The north set of doors were open at the time of the accident.

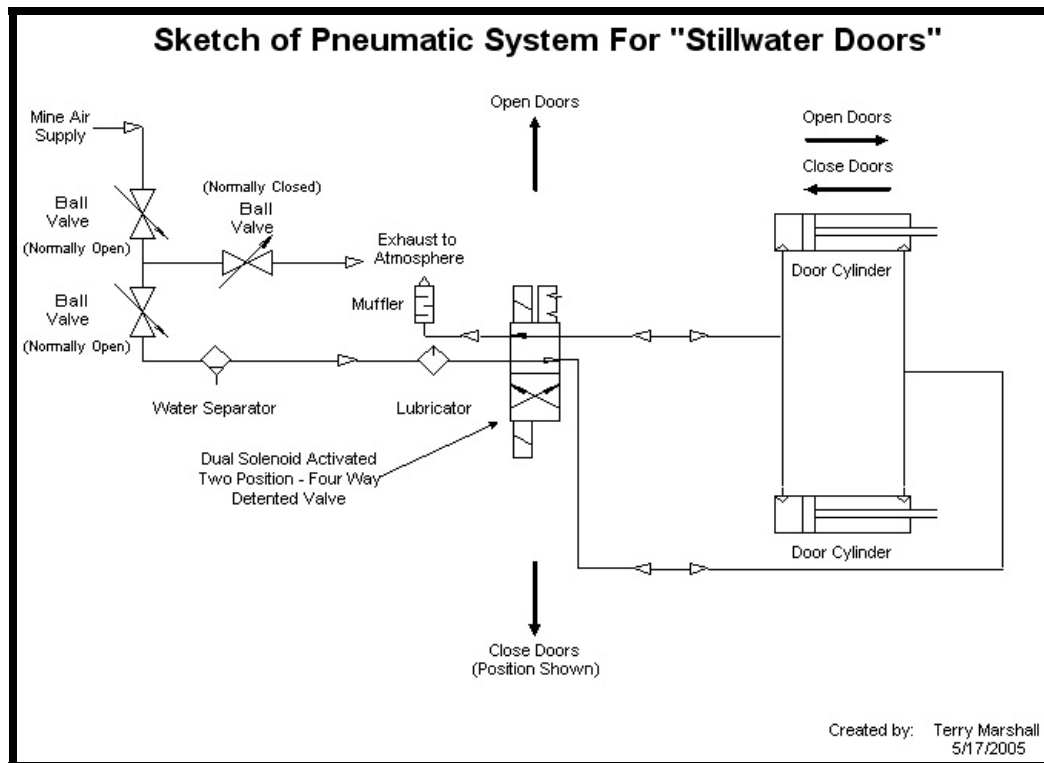
**Figure No. 2**

A sketch of the control system for the pneumatic actuated cylinders is shown in Figure No. 2. Electrically operated solenoids actuated a 4-way, 2-position valve for a door open and a door close position. Constant pressure was provided to the respective side of the pneumatic cylinders even when the doors completed the opened or closed cycle. The cylinders applied a force to the doors at all times during normal operation.

The pneumatic control system was functionally tested and the control valve was disassembled for visual inspection. No internal leaks were observed during testing that could cause unintended actuation of the door cylinders. No problems were identified with the pneumatic control system or the disassembled control valve that may have contributed to the accident.

Product information indicated that the seven-inch bore cylinder was capable of producing approximately 3,726 pounds of pulling force at 100 pounds per square inch. Using this information, it was estimated that the door edge that pinned Mathewson would have exerted a crushing force of approximately 650 pounds on him.
